SERVICE MANUAL

471X1A6565

IV. SYSTEM WIRING DIAGRAM

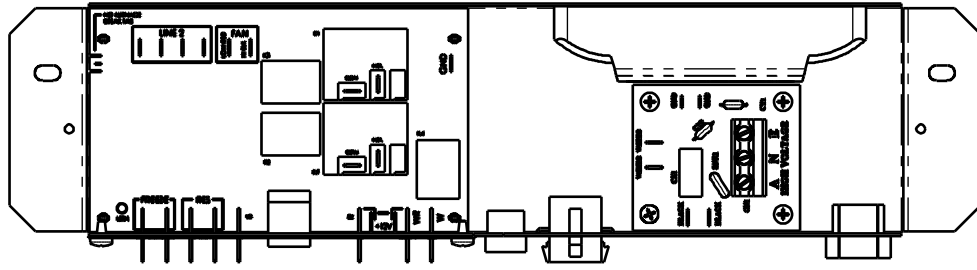
FIGURE 2

First, replace electronic board in ceiling assembly. If unit still does not operate, replace main control box (See Figure 2).

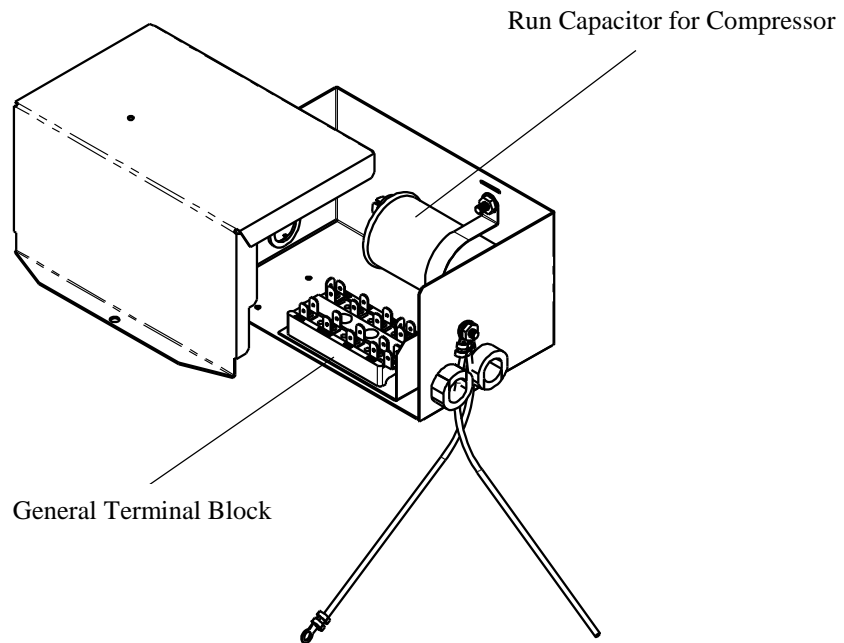
FIGURE 3

<u>Likely Causes</u>	<u>Correction</u>
Run Capacitor	Check run capacitor inside of electrical box situated under condenser fan (See Figure 3). Replace if defective.
Compressor Overload	Check compressor overload switch on compressor. Replace if defective.
Freeze Switch	Check freeze switch to ensure that the contacts are closed.
